2015 Environmental Resources Inventory
for
BOROUGH OF ROOSEVELT, NEW JERSEY

Executive Summary
2015 Environmental Resources Inventory for
BOROUGH OF ROOSEVELT, NEW JERSEY

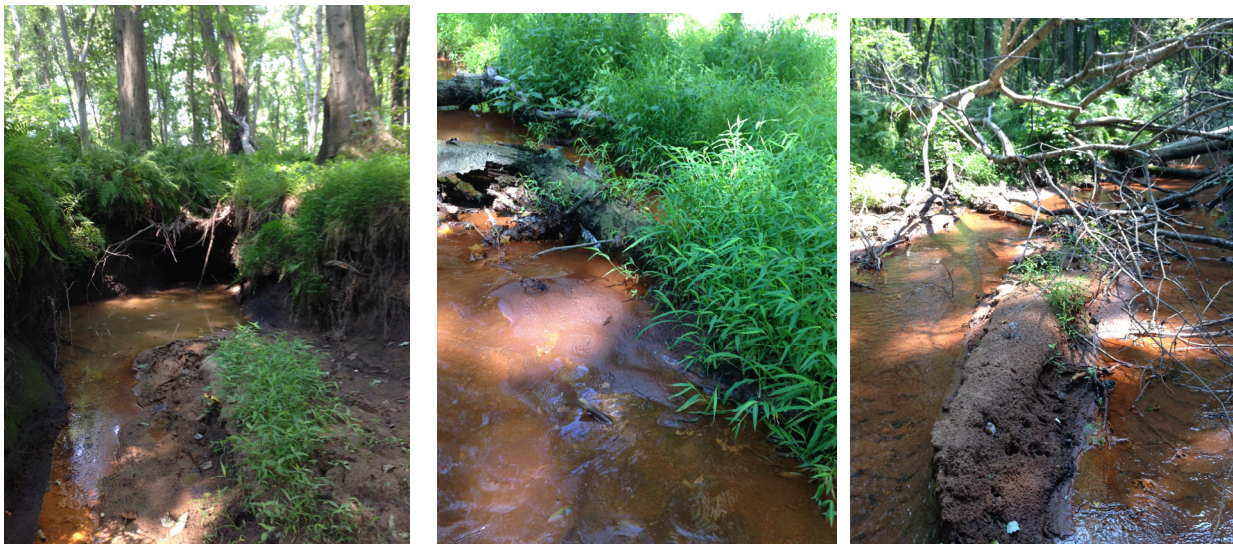
There are many areas of stream bank erosion and sediment deposition in Empty Box Brook.

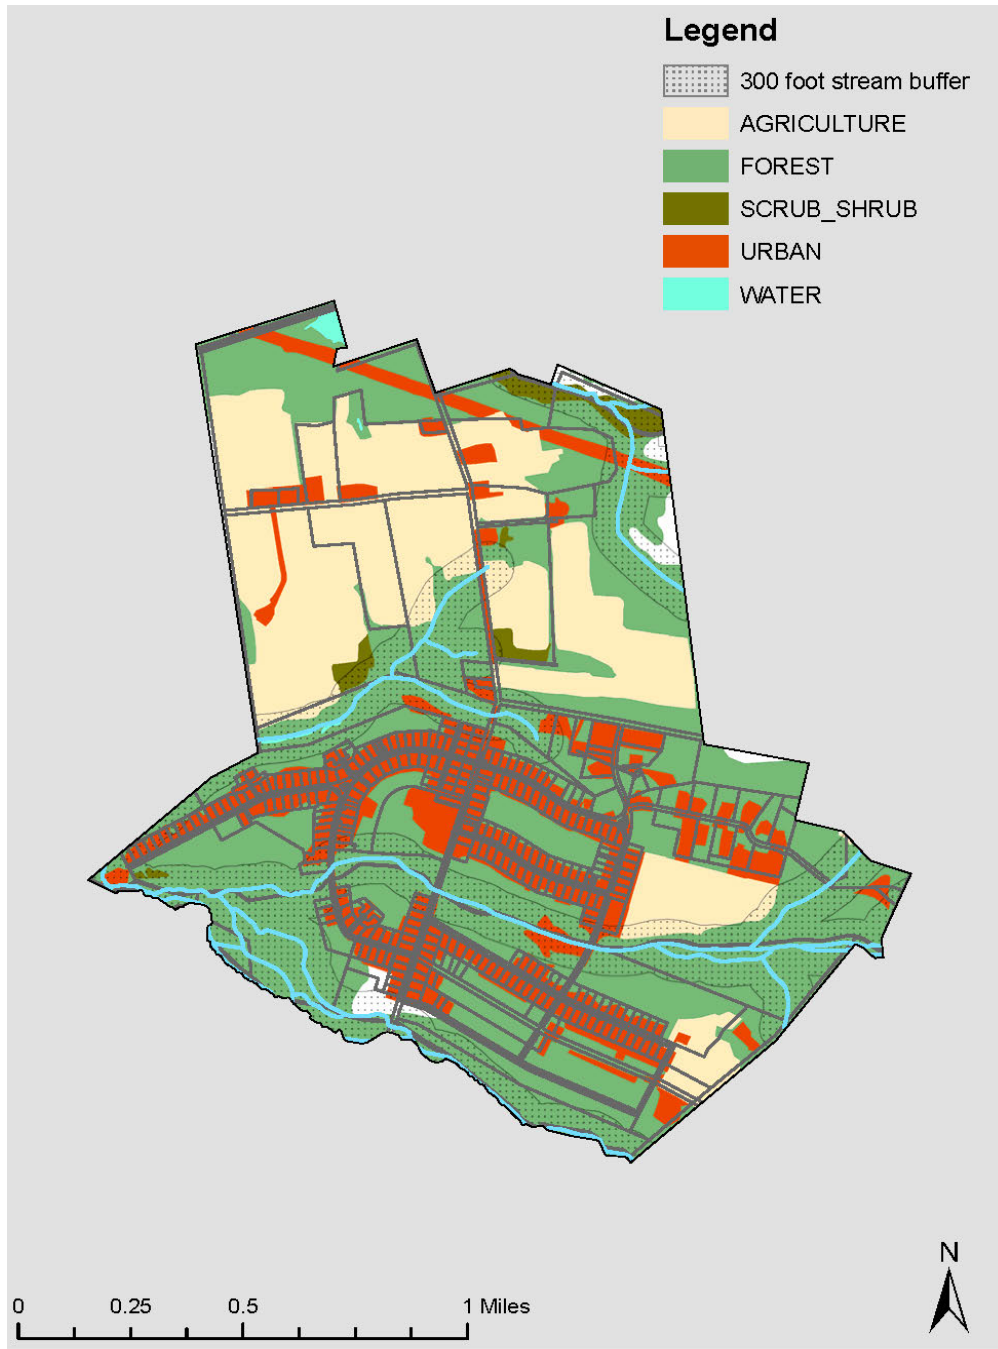
Map 1. Stream Buffer and Current Land Use. “Land Use” refers to the NJDEP 2007 data set that classifies land use and land cover from satellite images. Thus, the presence of a building or appearance of land clearing work may cause a property to fall into the “Urban” category and possible hay meadows will fall into “Agriculture”. Several properties are within 300’ of the streams in Roosevelt. This recommended buffer size is appropriate to the high water quality and Category 1 Stream Classification.

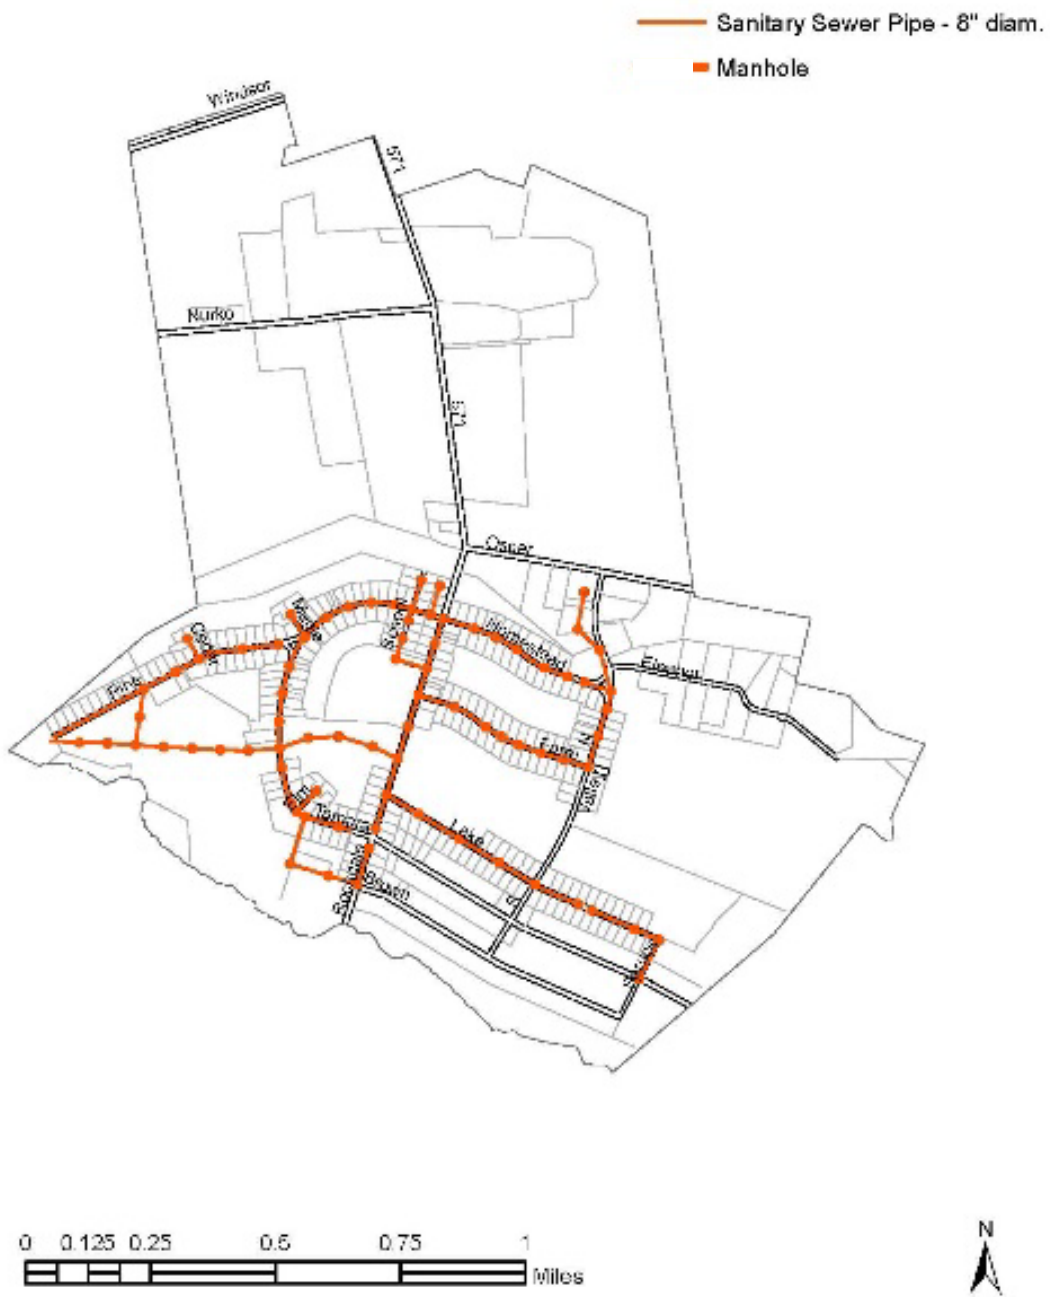
Map 10. Sanitary Sewer pipe distribution. (Derived from CAD drawing supplied by Roberts Engineering Group, LLC.)

Today, the public water system and the sanitary sewer system (Map 10 and Map 11) serve most of the population of the Borough. Current storm drain and storm sewer pipe locations were not available for this study. Because storm sewer pipes often release into streams, it is critical that these data be mapped. Further, if there is impact on stream morphology associated with storm drainage, small mitigation efforts can often protect the stream from development of major erosion problems.

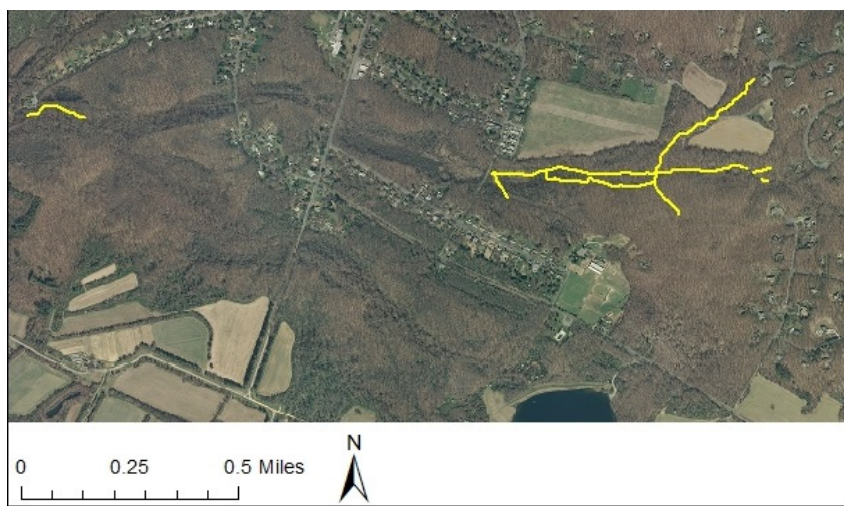
Photo 4: Stream Assessment Sample Area in Empty Box Brook.

Note that the area that was not sampled was very wet and a clear stream bed was difficult to find. In the eastern portion of Empty Box Brook, 125 observations of erosion were recorded. The most common process related to erosion severity was sediment deposition and the second most common was bank scour (Table 3, Photo 5 and 6). Table 4 shows the ease of access results of the evaluation. This metric is particularly useful when stream restoration is under consideration. Most samples are scored 1 or 2; this is considered difficult access. (The data sheet describes it as: *Must cross wetland, steep slope or other sensitive areas to access stream. Minimal stockpile areas available and/or located a great distance from stream section. Specialized heavy equipment required.*) This becomes important when proposals for stream restoration or remediation are made.

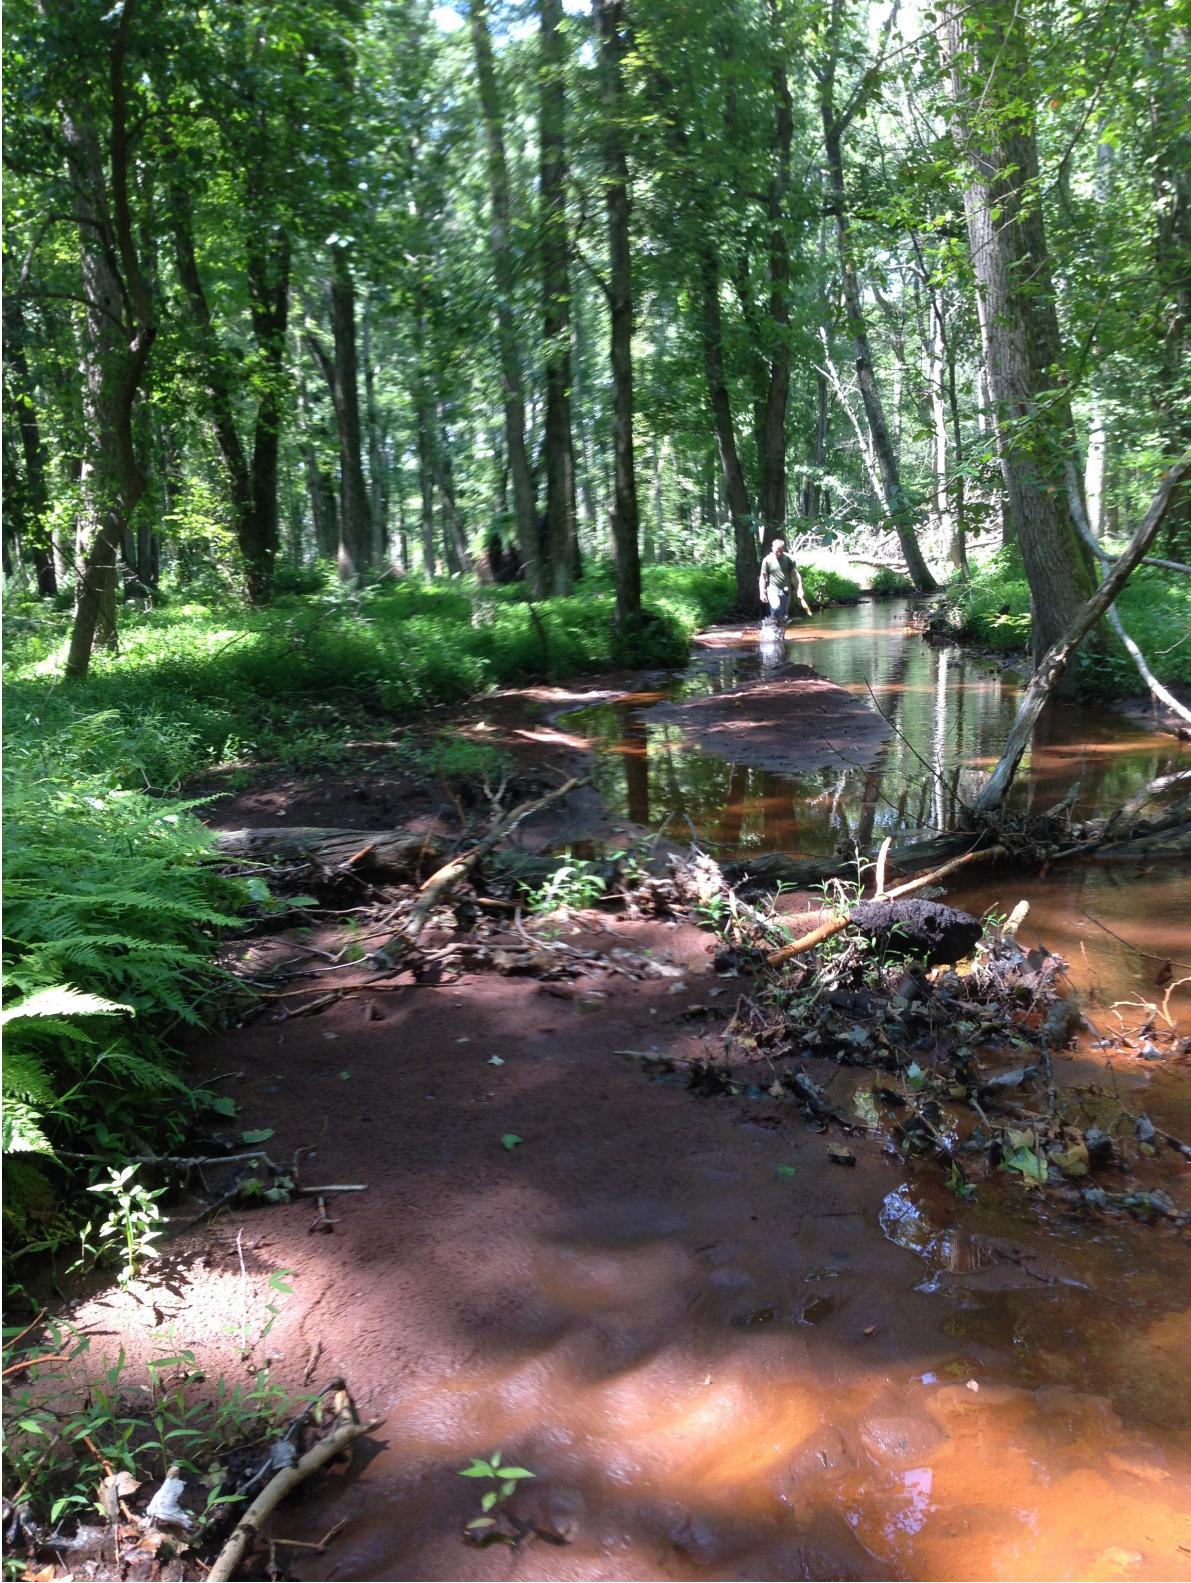
- Severe Bank Erosion
- Channel Modification
- Impacted Buffers
- Storm water outfalls
- Trash and debris
- Utility impacts

Photo 5. Examples of several Severe Bank Erosion Processes. Sample# ER17- Aggrading & Sediment Deposition.

- 4.) There is evidence of significant erosion in the upper stretches of Empty Box Brook, east of the Borough boundary. We found no evidence that this was caused by the beaver dam. Rather, it seems possible that sediments and a substantial increase of in storm-water input is coming from an area in Millstone Township. This requires on site investigation and the cooperation of property owners in the neighborhood. If additional construction occurs, the erosion could worsen if this is the cause of the pattern that was observed. Either way, it could be very productive to look into stream restoration grants (e.g. http://www.nj.gov/dep/grantandloanprograms/lga_ccpg.htm that could address the erosion, sedimentation, and invasive species dominance that characterized the eastern portion of Empty Box Brook.

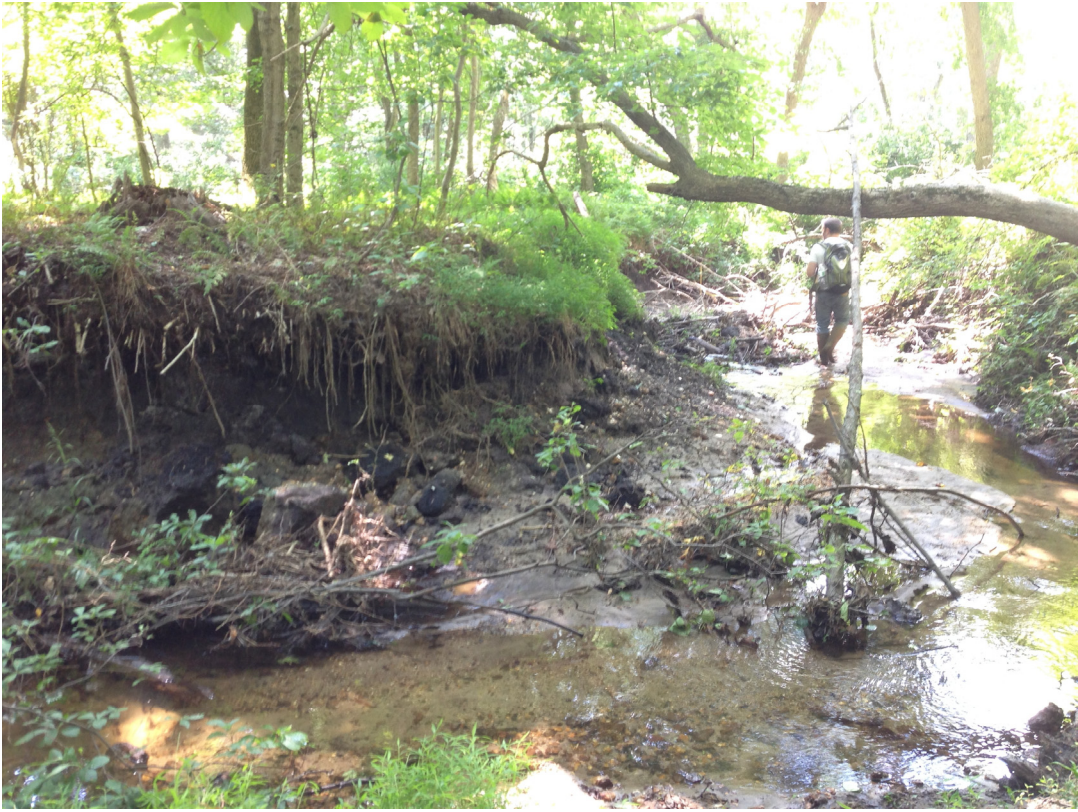
Photo 6. Bank Scour Deposition Example (Sample# ER94).
